## CAFO WPDES Compliance Report (07-21-14)

Inspection date: 07-10-14

Inspection type: Compliance, follow-up

Operation Name: New Horizons Dairy LLC

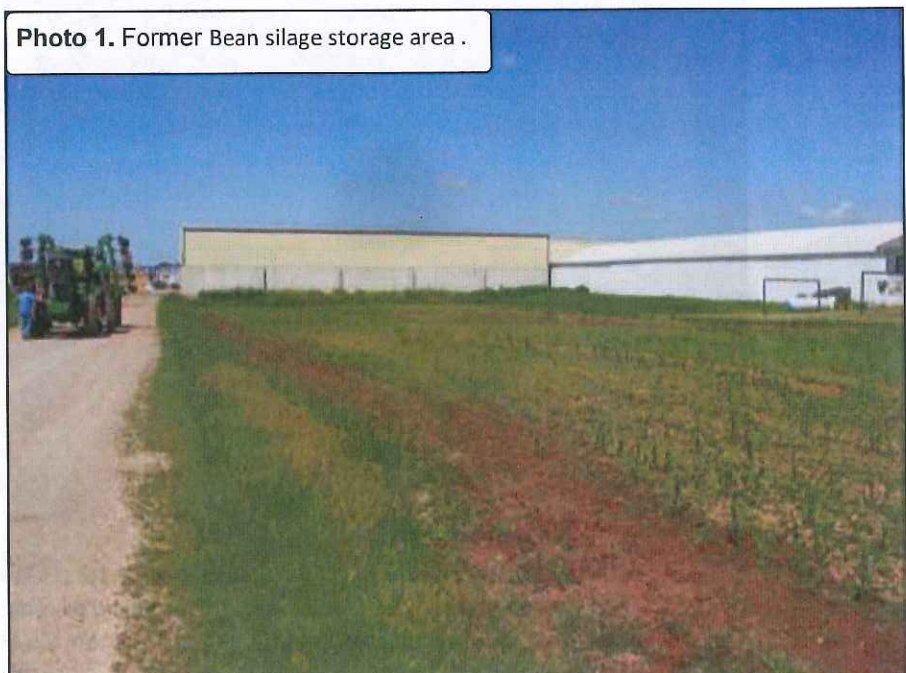
Feed Storage and Leachate Collection— Bean silage stored in grassy area along southern border of production area had been removed and the area had been cropped (Photo 1). Van De Hey stated that this silage was fed out less than a week after the April inspection. Plastic-covered hay previously observed along the railroad tracks had also been removed or feed out (photo 2). No runoff was apparent from these areas.

Photo 1. Former Bean silage storage area .

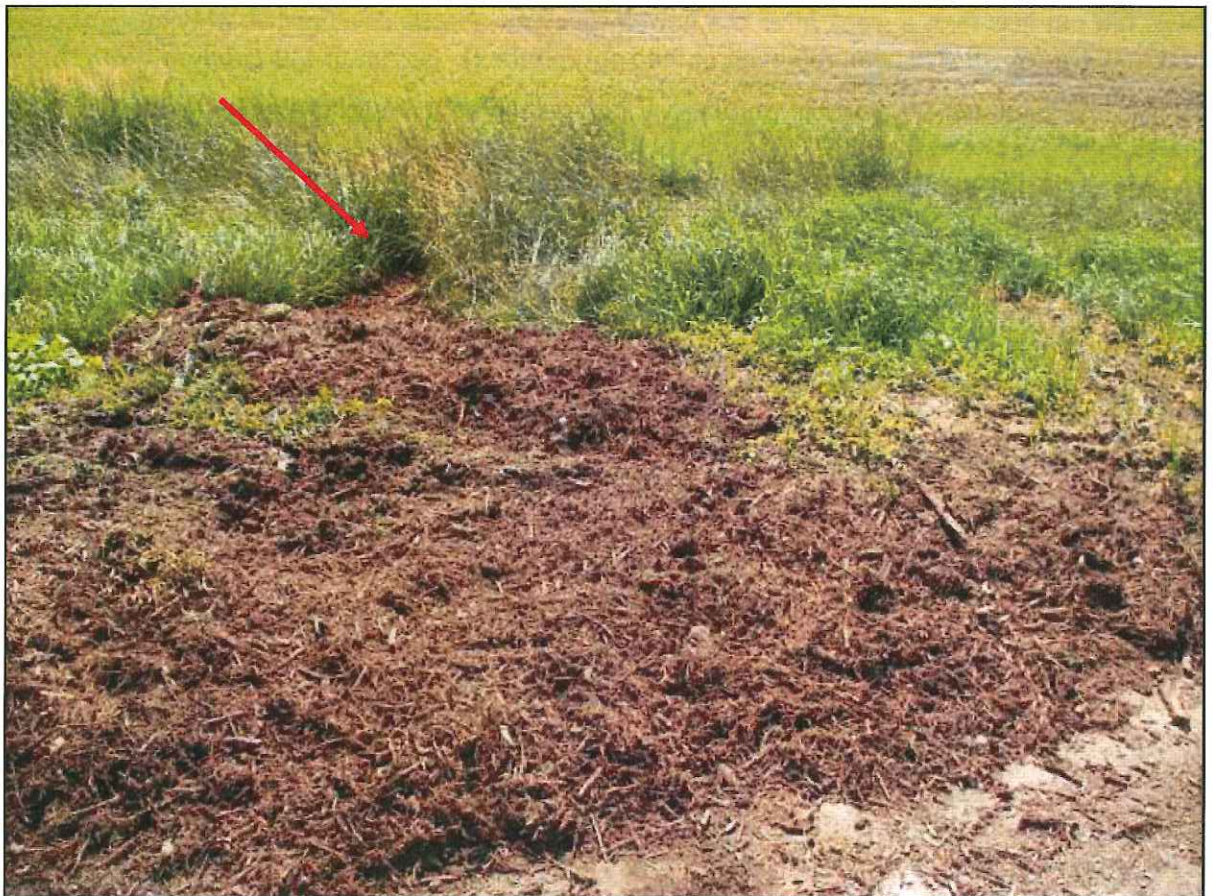
**Photo 2.** Former plastic-covered hay storage area.

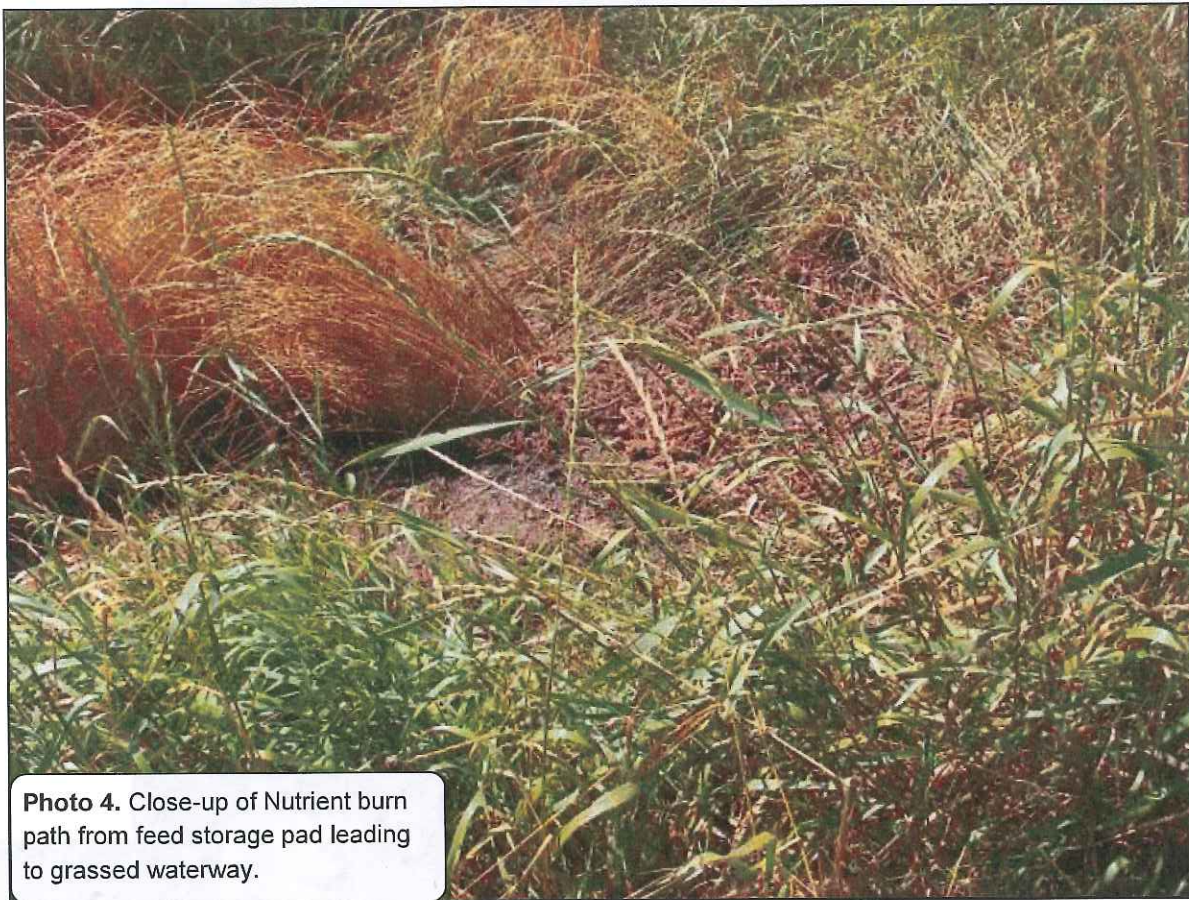
Some nutrient burn of vegetation was observed from the south east corner of the feed storage pad leading to the grassed waterway (photos 3-4). No signs of vegetation burn-out were seen in the grassed waterway.

**Photo 3.** Nutrient burn path from feed storage pad leading to grassed waterway. Foreground, shredded bark was placed up gradient of all nutrient burn paths by Van De Hey to aid in nutrient absorption.

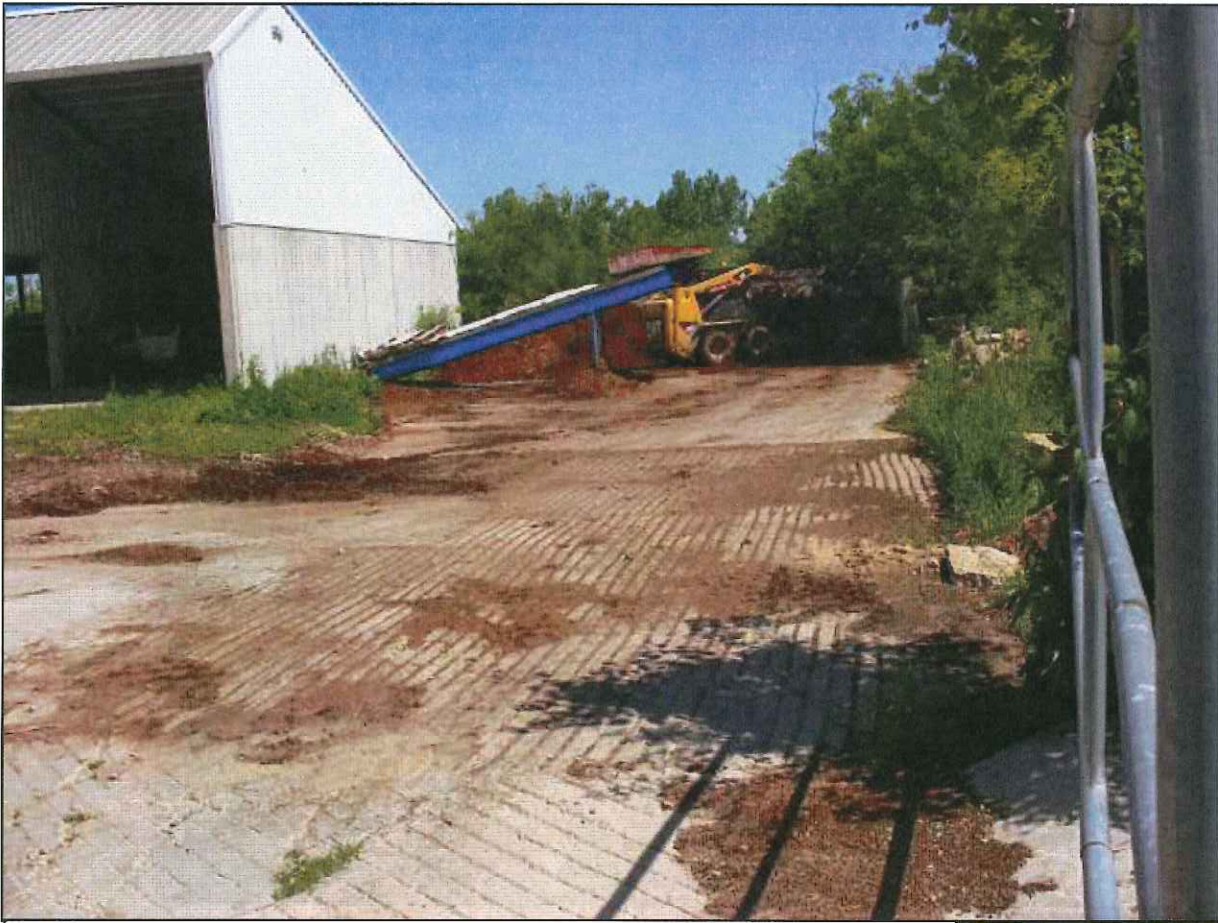
**Photo 4.** Close-up of Nutrient burn path from feed storage pad leading to grassed waterway.

Bedpack Stacking— Solid manure was being removed from the stacking area east of the calf barn at the time of the inspection (Photo 5). Van De Hey stated that the solid manure here was removed shortly after the inspection, and that manure being removed today will be stockpiled in an empty feed bunker to be applied to 2nd cut hay within the week. Uvaas noted that solid manure looked different today than during the April inspection (less fungal growth or more straw?). Van De Hey also noted that additional concrete chunks had been added around the perimeter of the stacking area to help retain manure as an interim measure.

**Photo 5.** Solid manure being removed from the stacking area east of the calf barn.

Uvaas informed Van De Hey that permanent improvements may be required as an outcome of the April U.S. EPA inspection in order to continue to stack solid manure here.

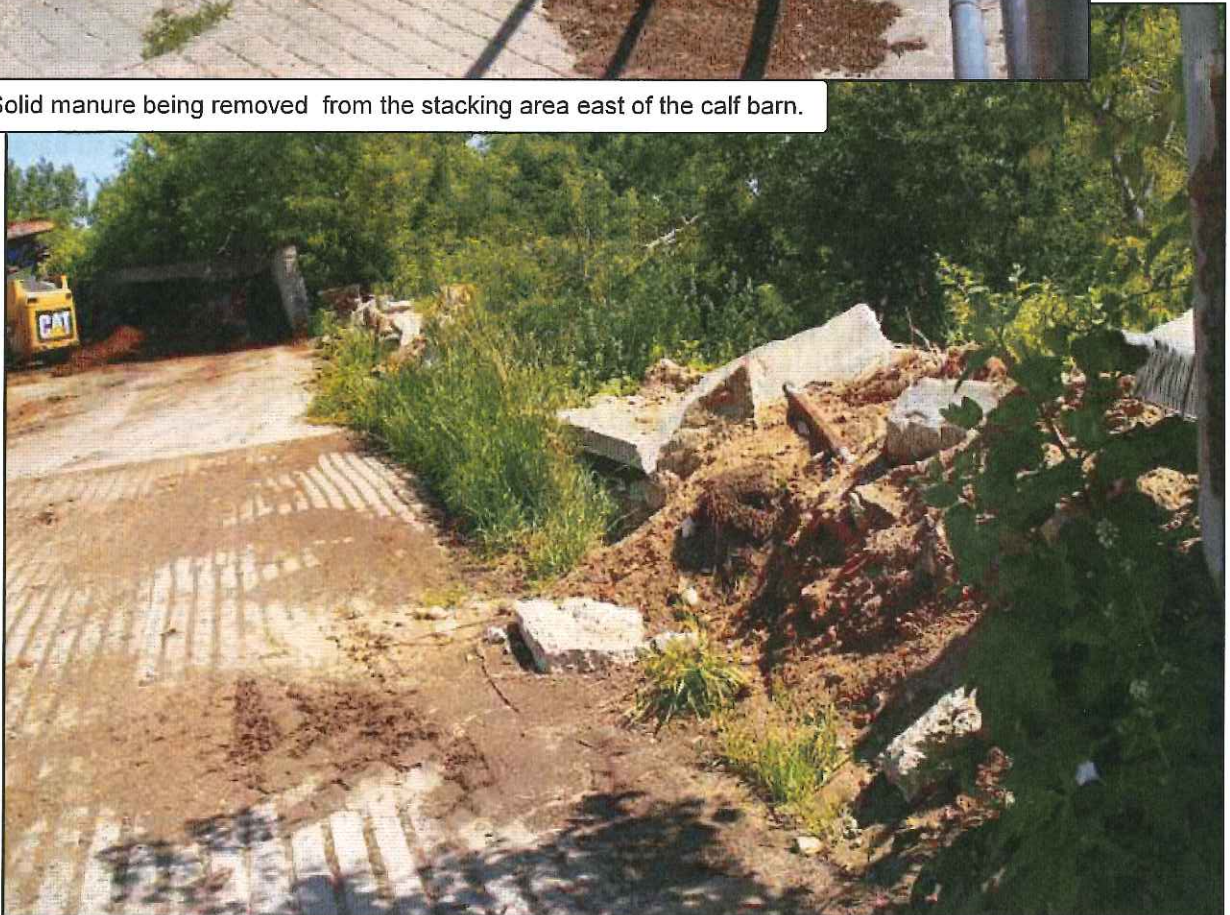
**Photo 6.** Close-up of concrete chunk interim containment measure.
